Taukkyan War Memorial

The contractor's view!

Matthew Reuter – Stonewest HK
Nick Wilson – Stonewest UK

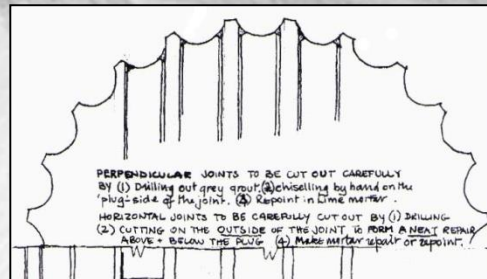
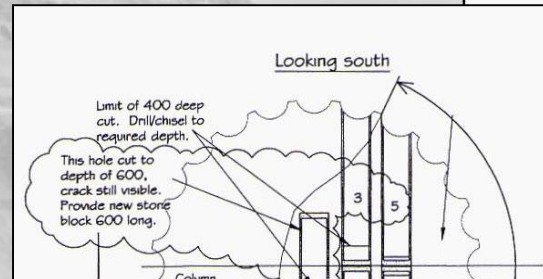
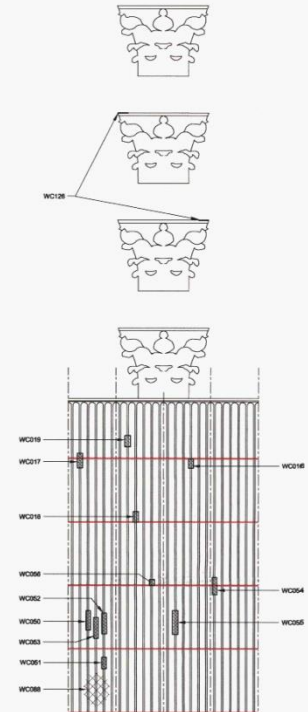
Structural Column Repair

Chain saw to cut slots across fracture line

150-600mm deep slots

Proprietary grout fixing for new indents

Fix new Portland stone indent

After setting - mason working to flute profile

Achieved structural repair but minimum intervention

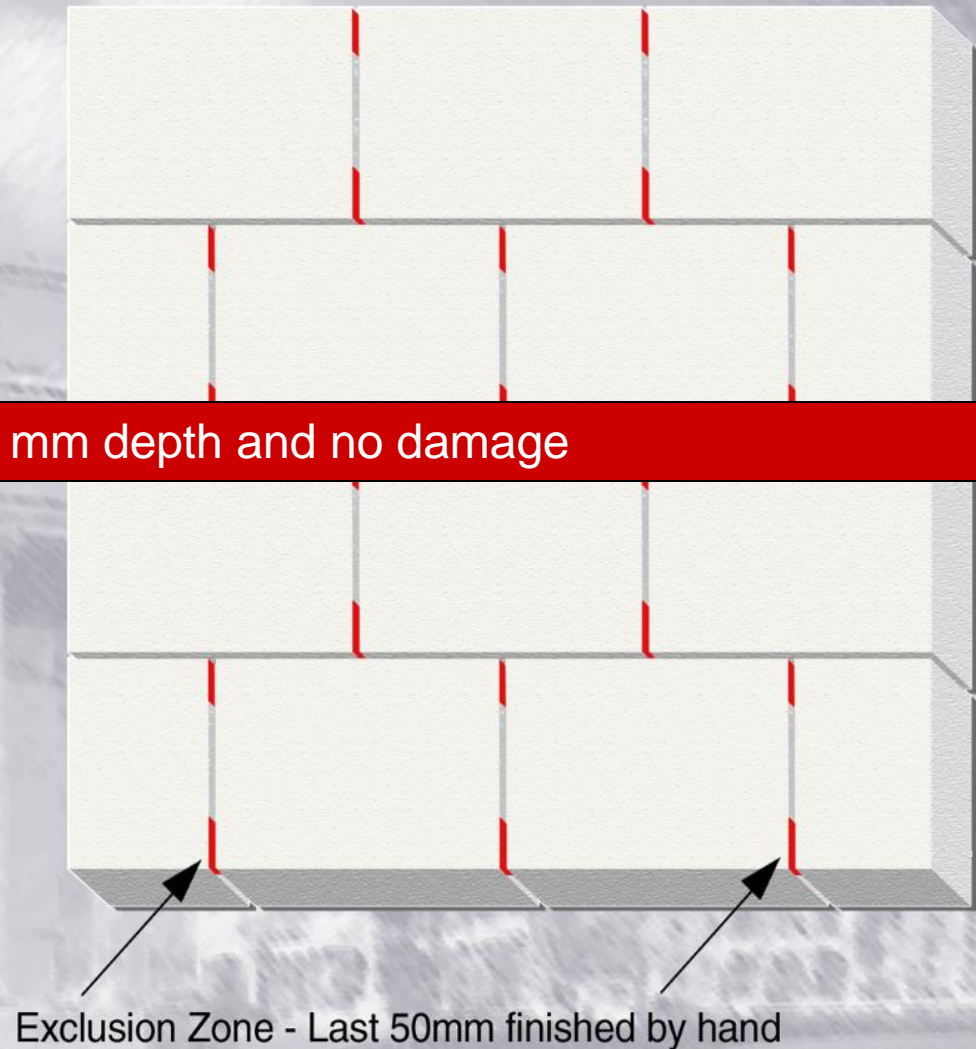
Repointing

- Very narrow joints
- Varying widths
- Spalls from previous building
- Bastard Joints
- Hard cementitious grout
- Specification called for hack

Achieved 25 mm depth and no damage

- Stonewest angle grinder demonstration
- Concluded to use angle grinder for bed joints and middle of perpend. Hacksaw to finish each end.
- 3 Parts Stonewest sieved Portland mix; 1 Parts St Astier NHL3 lime

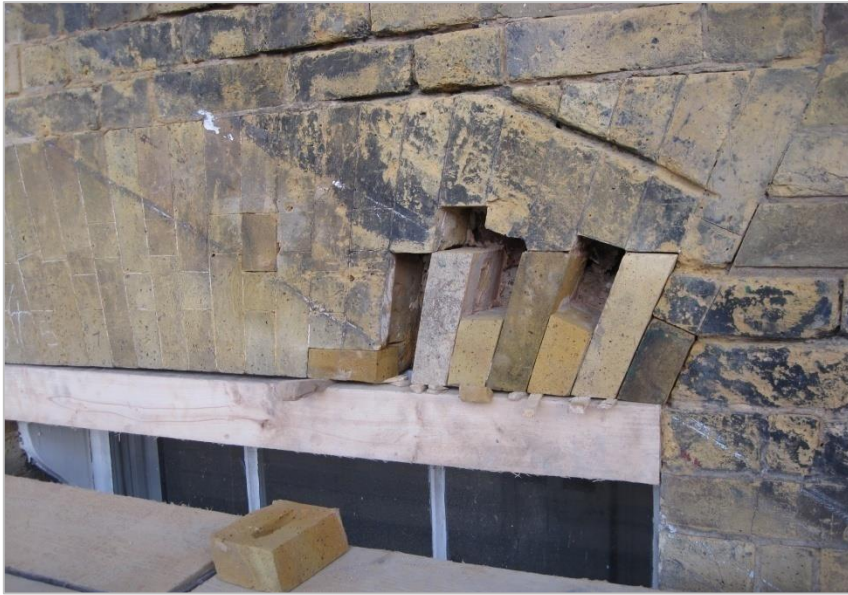
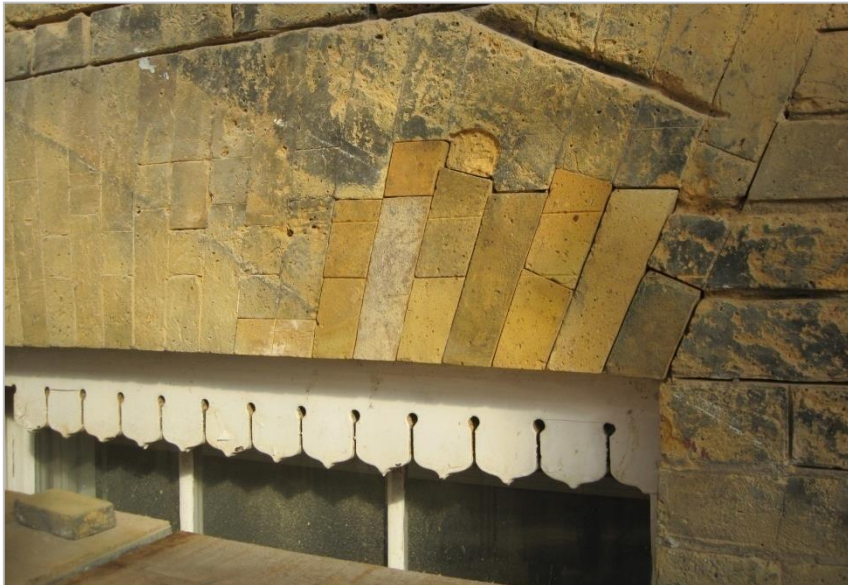
Brick Repairs

- Replacement of missing arch bricks.
- Reclaimed bricks from other similar areas of the site
- All bricks re-cut and hand finished on site for accuracy.
- Skill of the mason/ brick-worker paramount at this stage.
- Experience and understanding of traditional materials absolutely necessary.

- Newly cut re-claimed bricks propped on former and bedded with Lime putty (Non hydraulic “fat Lime” high in calcium carbonate) and a fine washed silver sand.
- Re-use of existing material was a Stonewest driven solution to the Network Rail vision for keeping and re-using materials across all trades for the project.
- Benefits to the Project
- Environmentally friendly approach
- Minimal transport
- Minimal new production
- Sustainable
- Minimal cost

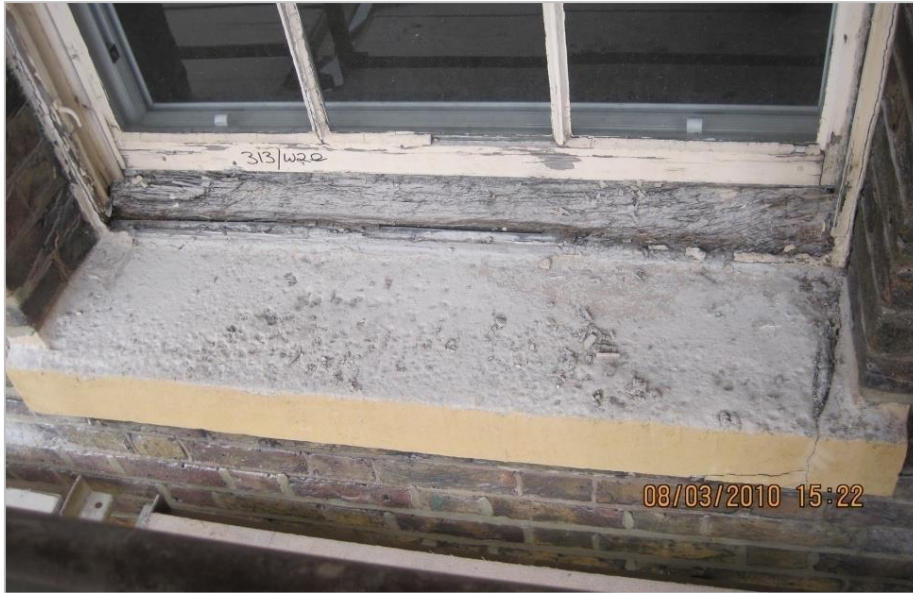
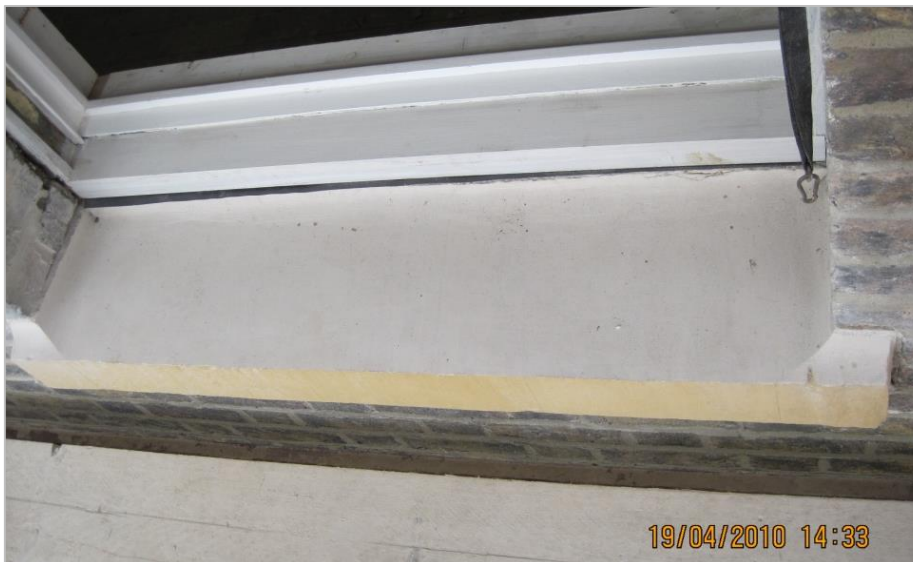
Stone Repairs

- Existing Portland stone sill profile **re-worked** to remove water traps due to weathering.
- Rather than renew completely, heavily weathered surfaces were **taken back to sound clean** surfaces.
- **No new** materials required
- Re-dressing giving circa.50 years extra life to stonework
- Re-worked using spinners and stooling worked **by hand** to corners.

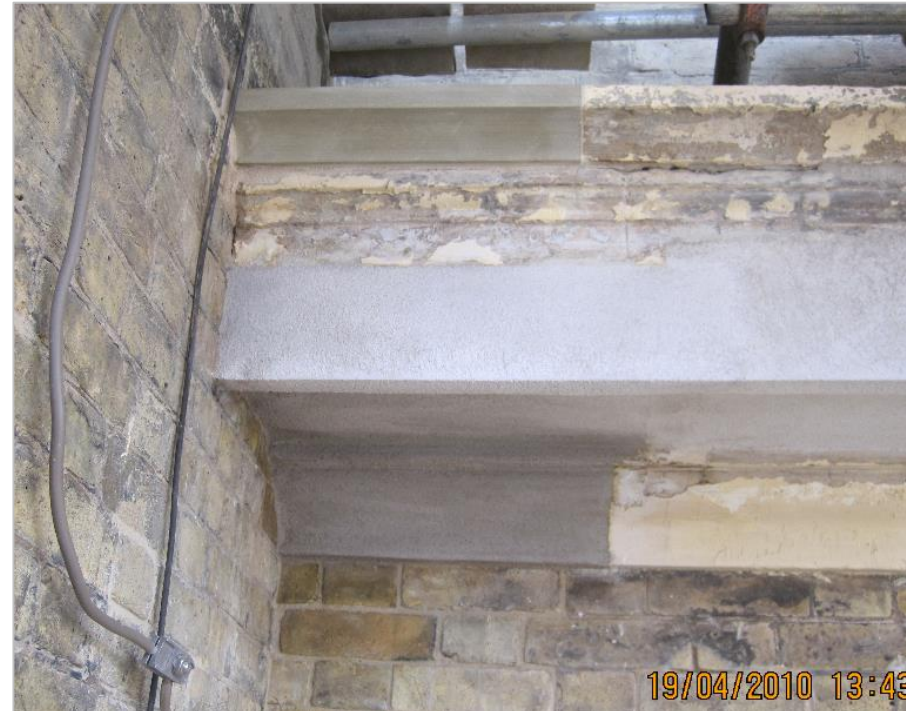
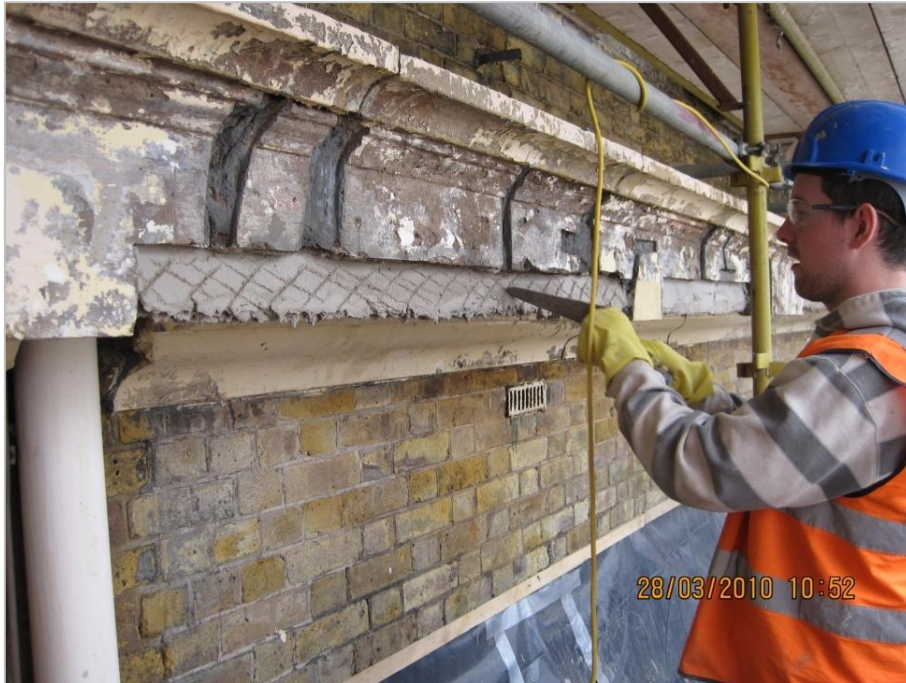
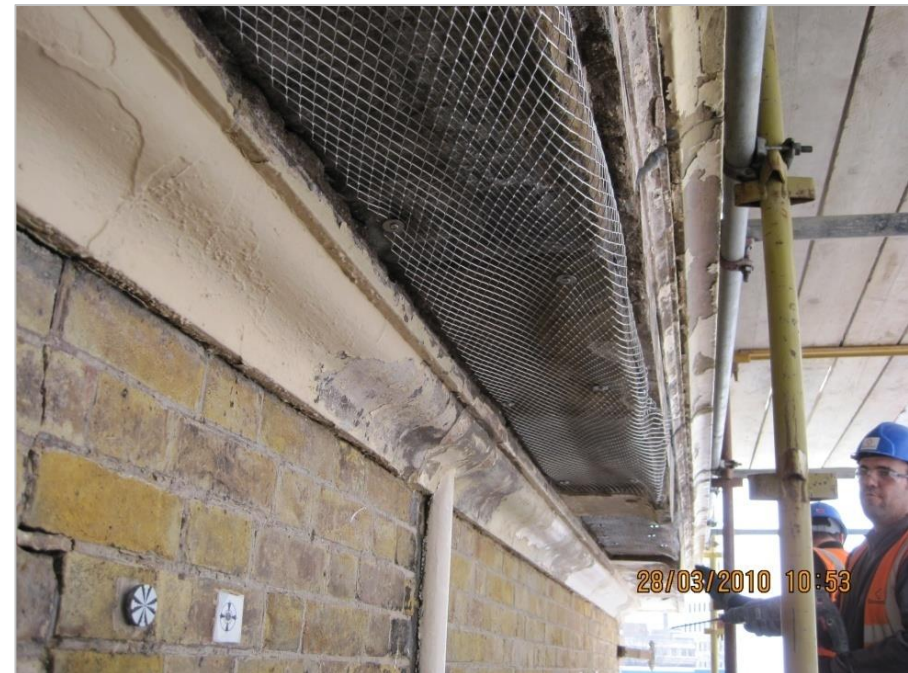
- [Expanded metal lath](#) in stainless steel used as backing material armature to form the shape.
- [Original bonded to Sandstone](#) (poor adhesion and delaminating)
- [English.Heritage](#) discussion and approval given
- New stucco applied to this framework.

- Stucco Mixes: [4 coat work..](#)
- Slurry/Bonding coat: Brush / Trowel
- Backing /Core coat: (1:2) Trowel
- Scratch coat: (1:2) Trowel
- Finish coat: (1: 2) Trowel / Floats

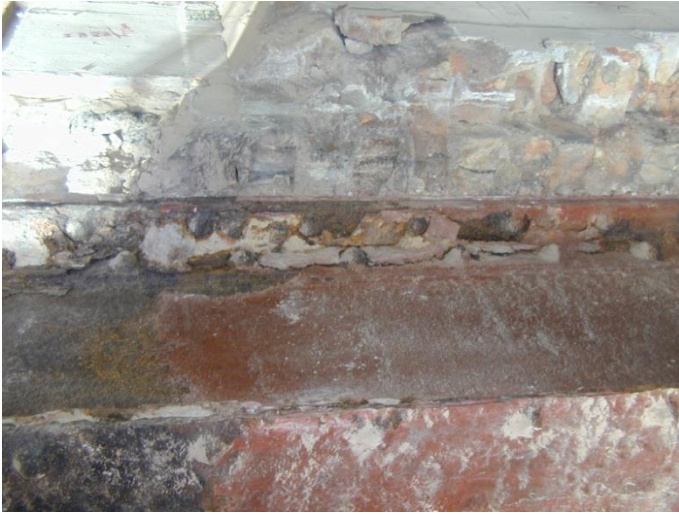
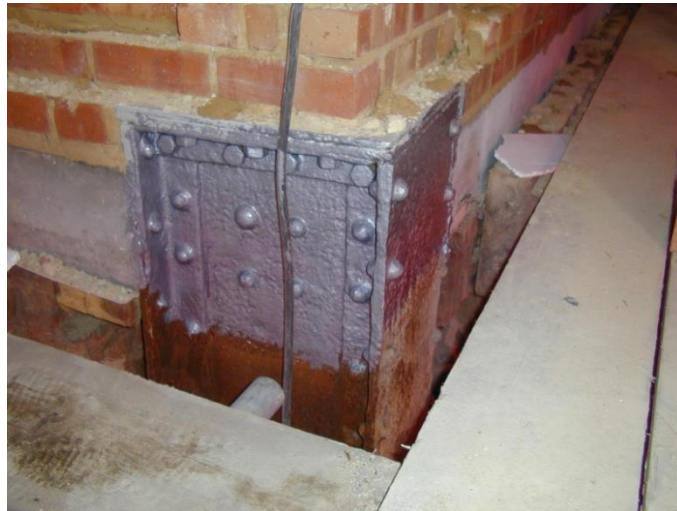
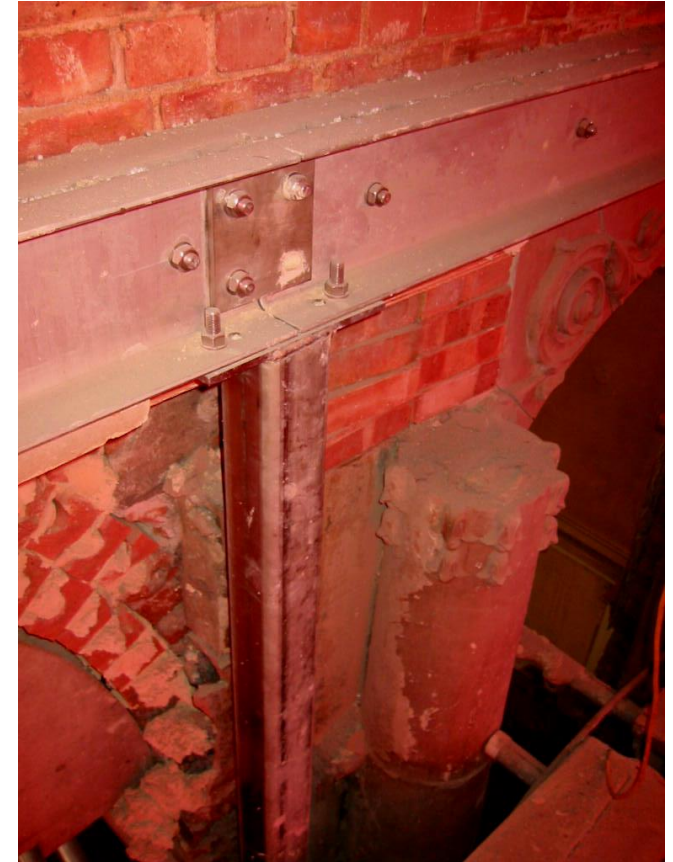
Treatment of Existing Structural Steel

Exposed

Cleaned of
rust and
treated with
Hempel
marine-
grade paint

Reinforced/replaced

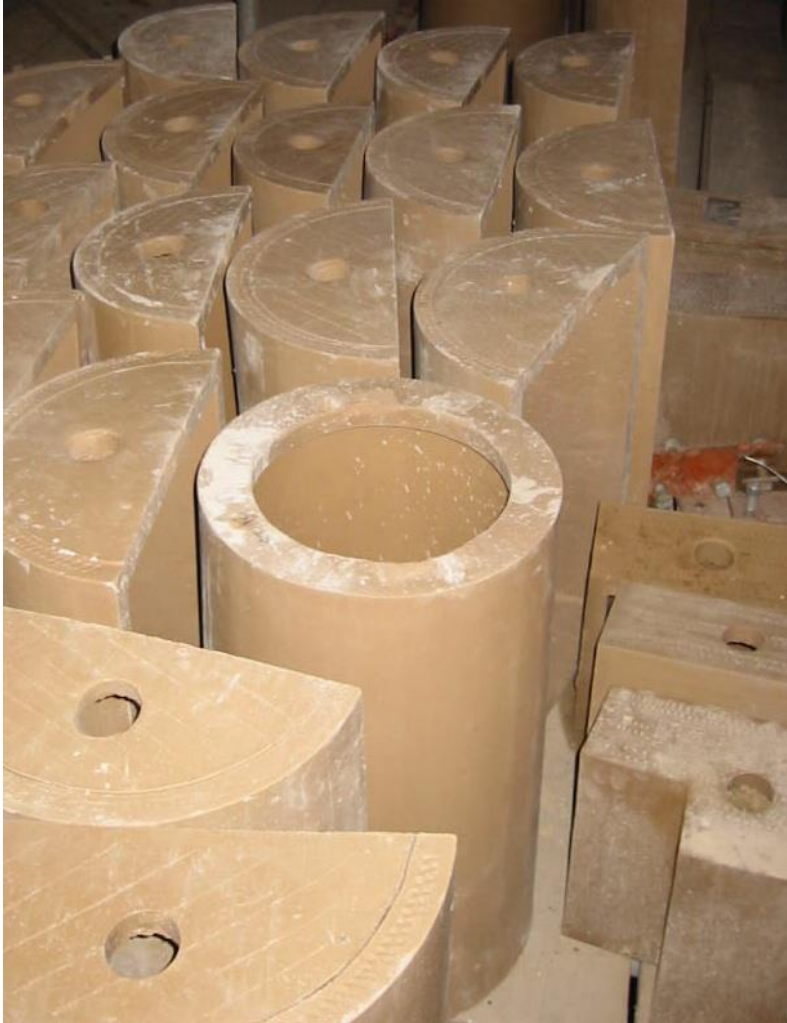
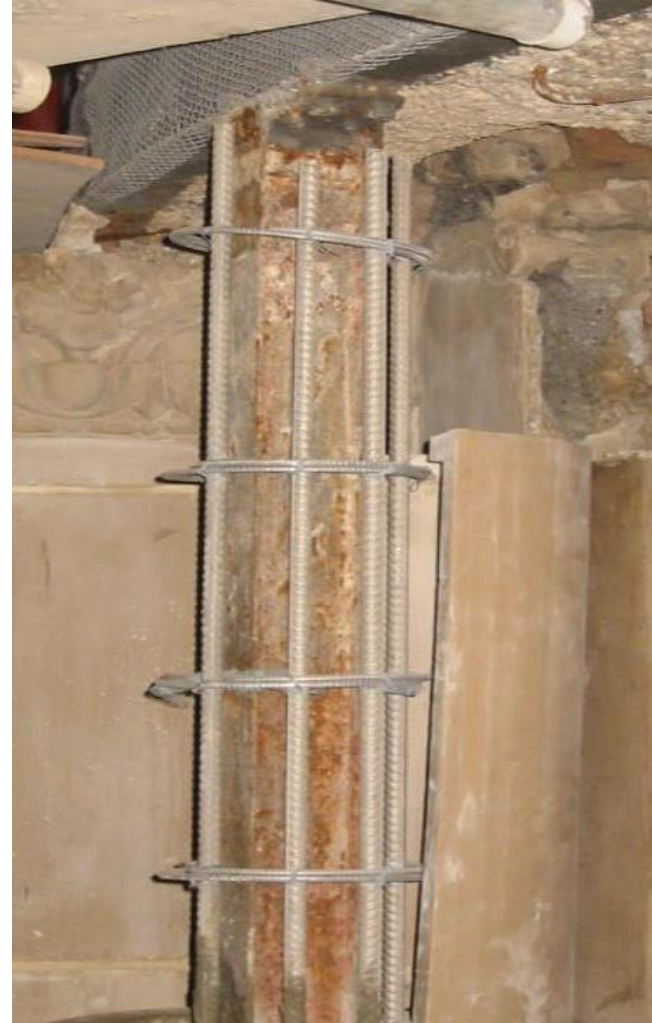
Colonnade – Terracotta Renewal

Replaced with GRP in 80's – new terracotta and reinforcement required

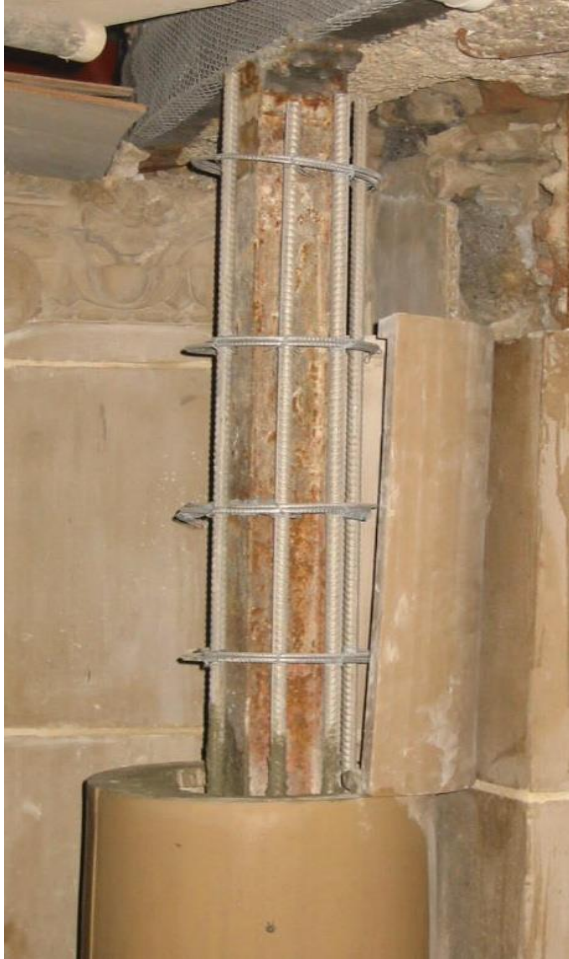
Colonnade - continued

T-16 structural support
surrounding original steel
