Taukkyan War Memorial

The contractor's view!

Matthew Reuter – Stonewest HK
Nick Wilson – Stonewest UK

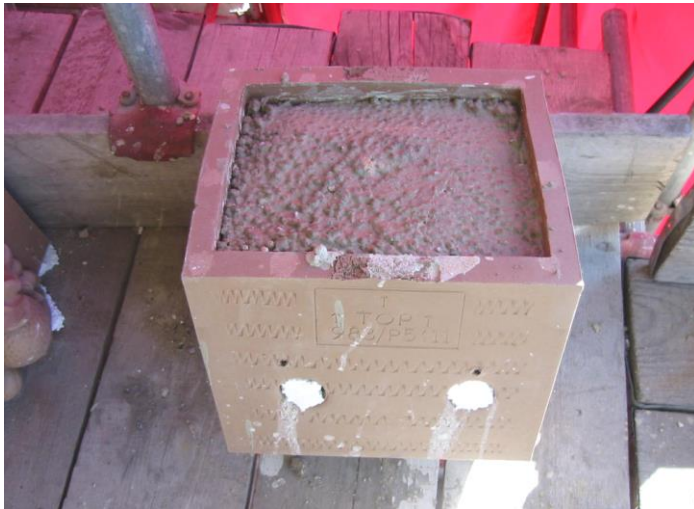
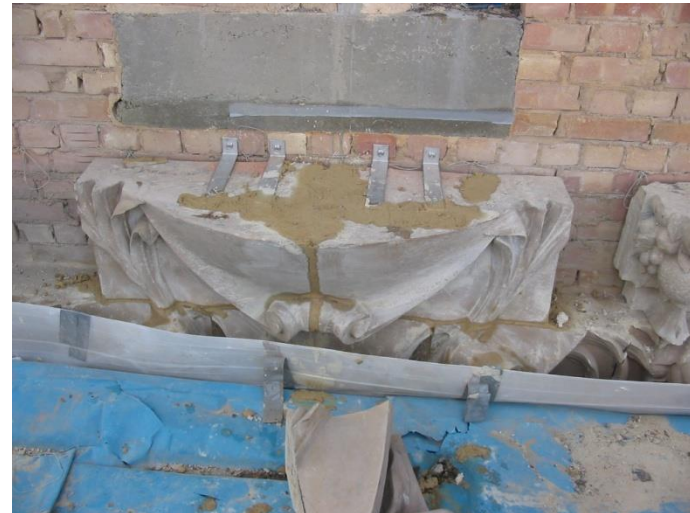
The Main Cornice

The largest blocks on the building – over a metre square

Drying time for blocks of up to 2 months

Internal reinforcement (additional 'walls') required

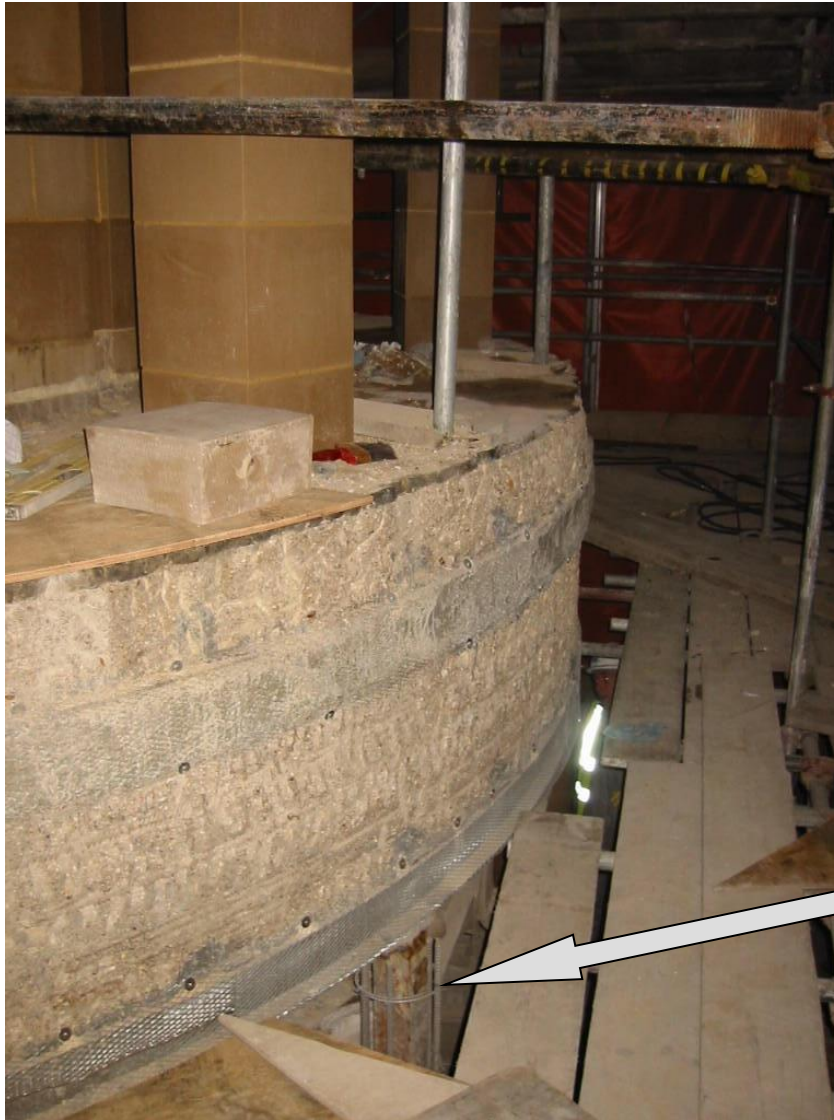
This shows the area
prior to these works

The Entablature
(above the
colonnade) was
reinforced and a
waterproof render
applied
